# Manhole Inspection Summary

Manhole # S29OO1011MH

Insp Date: **6/20/07 2:56 PM**

**Location** Address: **COLD SPRING LN**

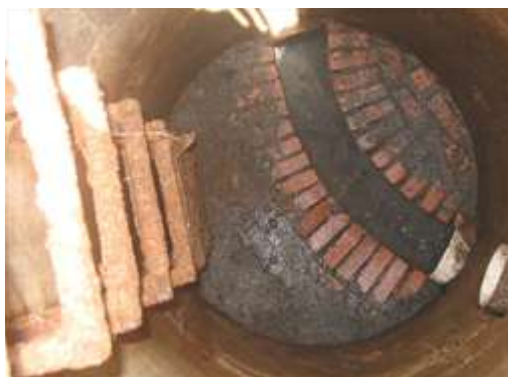
Top View

Corroded steps. Evidence of surcharge - Bench debris. Channel debris.

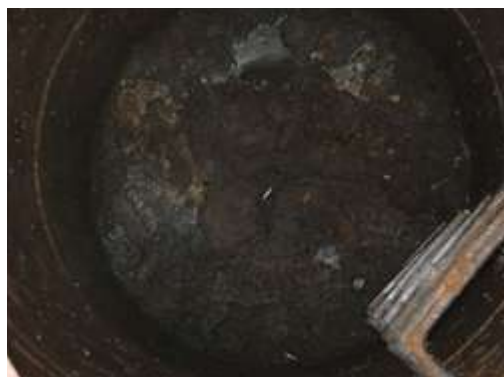
heavy surcharge evidence

needs cleaning

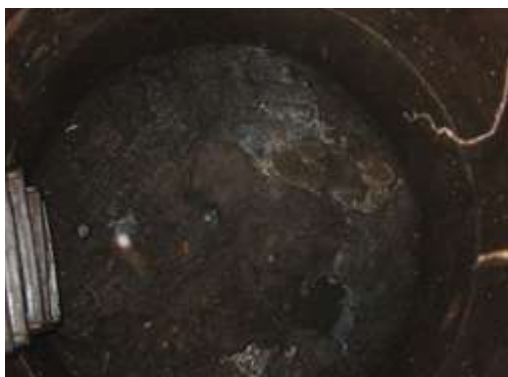
Defect

active surcharge

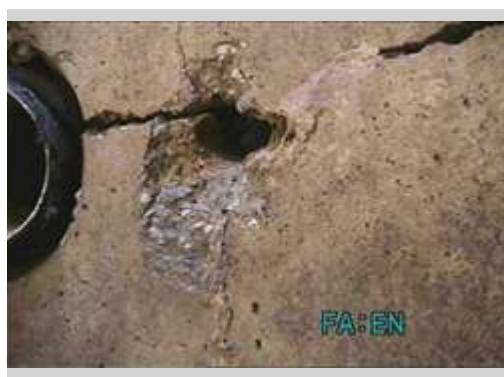
Defect

Condition: ☐ Sound ☒ **Cracked** ☐ Root Intrusion ☐ Loose Brick ☐ Deteriorated

Infiltration: ☐ None ☐ Joint ☒ **Cracks** ☐ Mortar ☐ Roots ☒ **Wall**

Barrel cracks and infiltration.

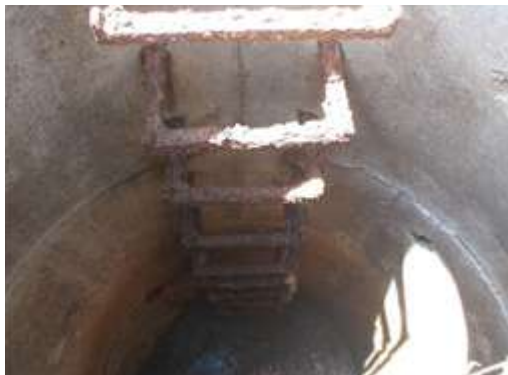
Defect

Infiltration: ☐ None ☒ **Joint** ☐ Cracks ☐ Mortar ☐ Roots ☒ **Wall**

Adjustment and Barrel infiltration.

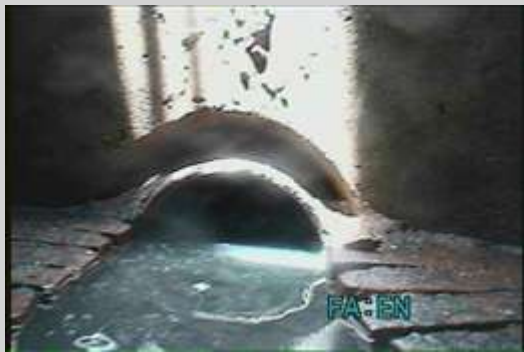
## 10 in. Circular Gravity Sewer Pipe Out @ 12 O'Clock

Comments **Both the O12 and the I5 pipe seals are not flush to the pipes.**

Bench deterioration.

Deposits: ☐ None ☒ **Mud** ☐ Sludge ☒ **Debris** ☐ Grease

Silt Depth: **5** (in.) Deposits Extent: **Medium**

Infiltration: **Evidence** Pipe Seal Cond: **Unknown**

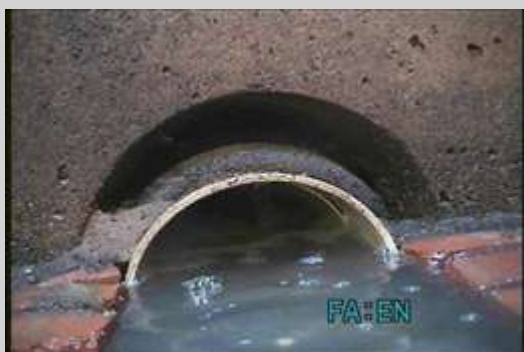
## 8 in. Circular Gravity Sewer Pipe In @ 5 O'Clock

Deposits: ☐ None ☒ **Mud** ☐ Sludge ☒ **Debris** ☐ Grease

Silt Depth: **2** (in.) Deposits Extent: **Light**

Infiltration: **Evidence** Pipe Seal Cond: **Unknown**

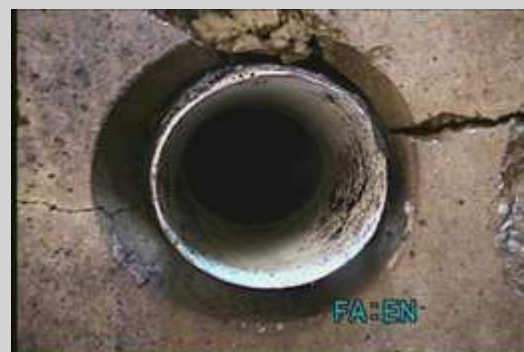
Drop In @ 5 O'Clock

Drop: **Outside** Rod and Bar

Drop Condition: **Open**
